USAAVRADCOM TR 78-2

AD A 054906 **FIELD EVALUATION OF THE SHOCK PULSE TECHNIQUE TO UH-1H SERIES HELICOPTERS**

5 JUNE 1974

FINAL REPORT

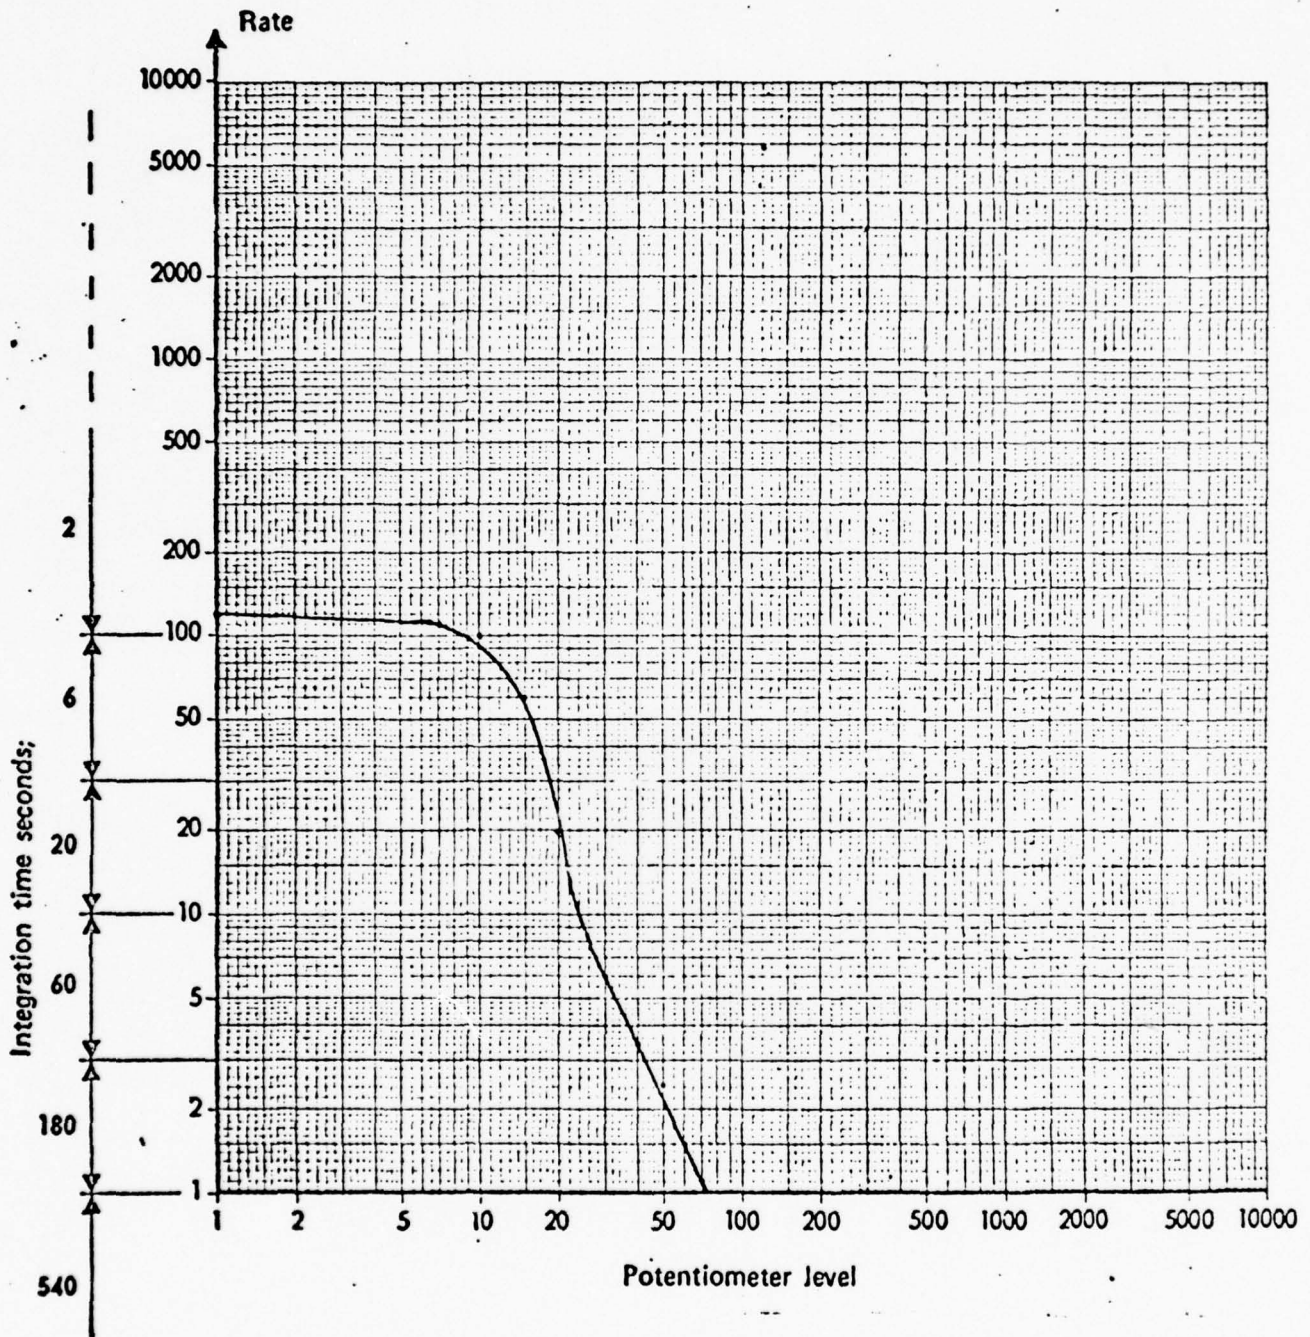
FIG. 10

Hanger Bearing Serial #A20-11446 (Fig. 10) was removed for analysis because of the high potentiometer level of 1200 plotted and the excessive needle swing present in plotting the curve. This was the only hanger bearing which manifested such excessive needle swing on the MEPA-10A shock analysis. Reviewing the teardown data from BHC, a general good condition is reported with the only damage being corrosion in two places

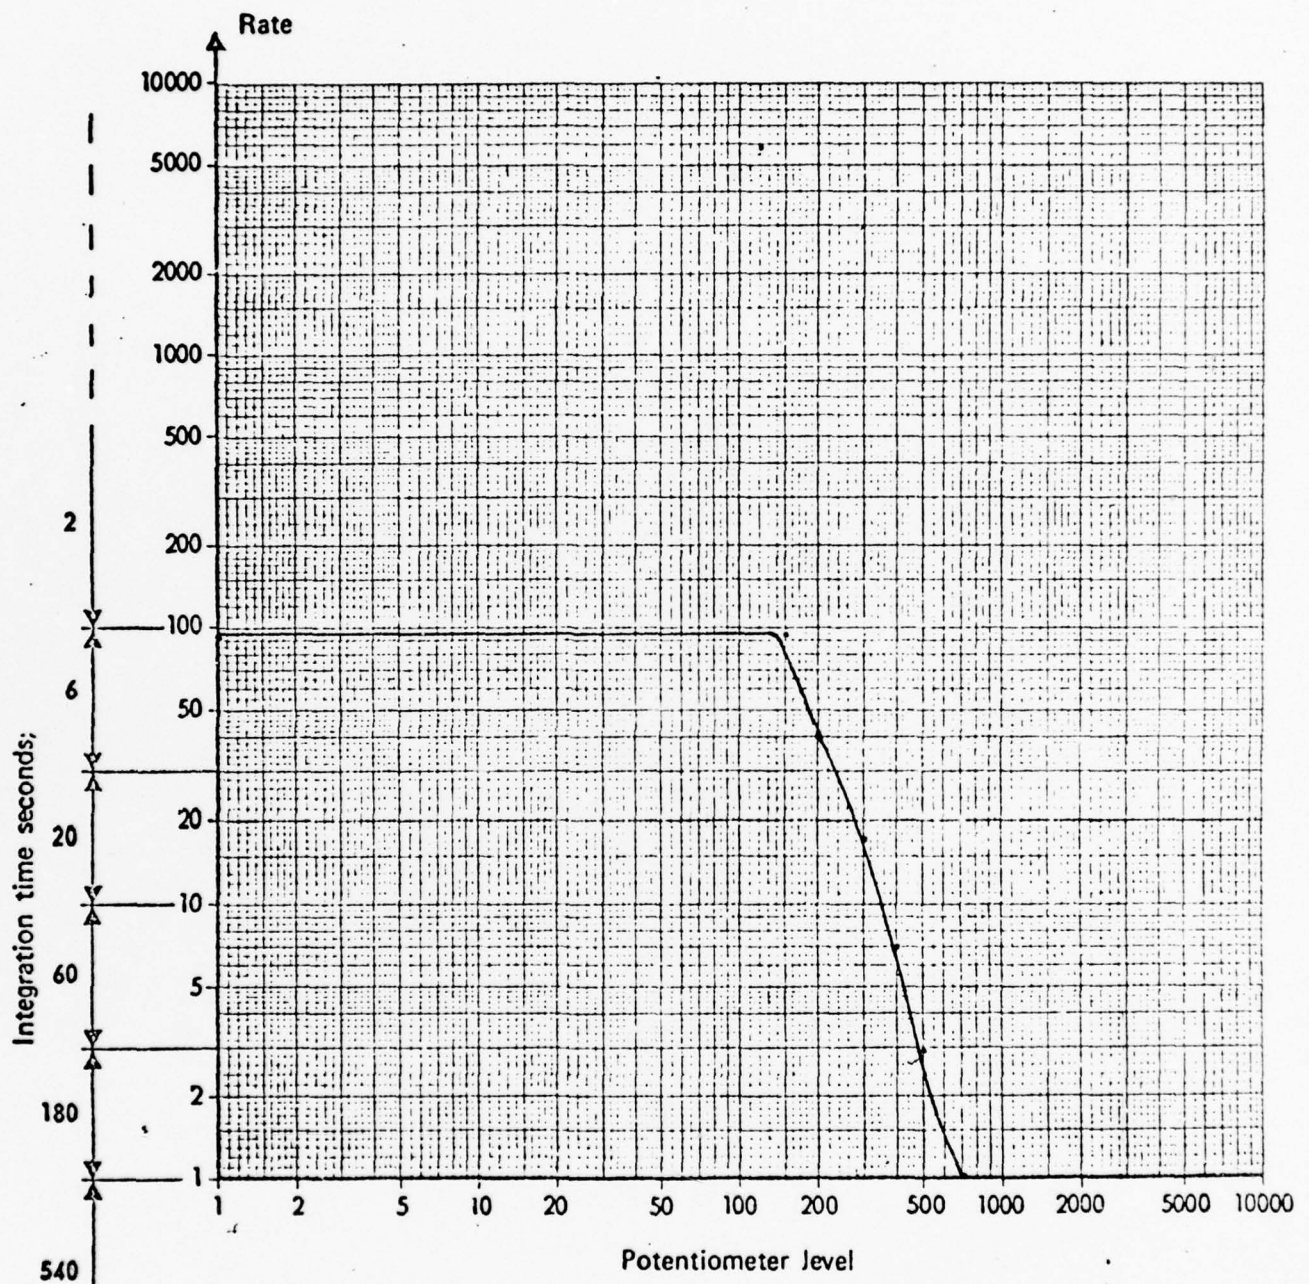
FIG. 17

RATE APPEARED LESS THAN NORMAL WITH POTENTIOMETER LEVEL IN EXCESS OF NORMAL. BEARING WAS NOT REMOVED FOR PHYSICAL ANALYSIS.

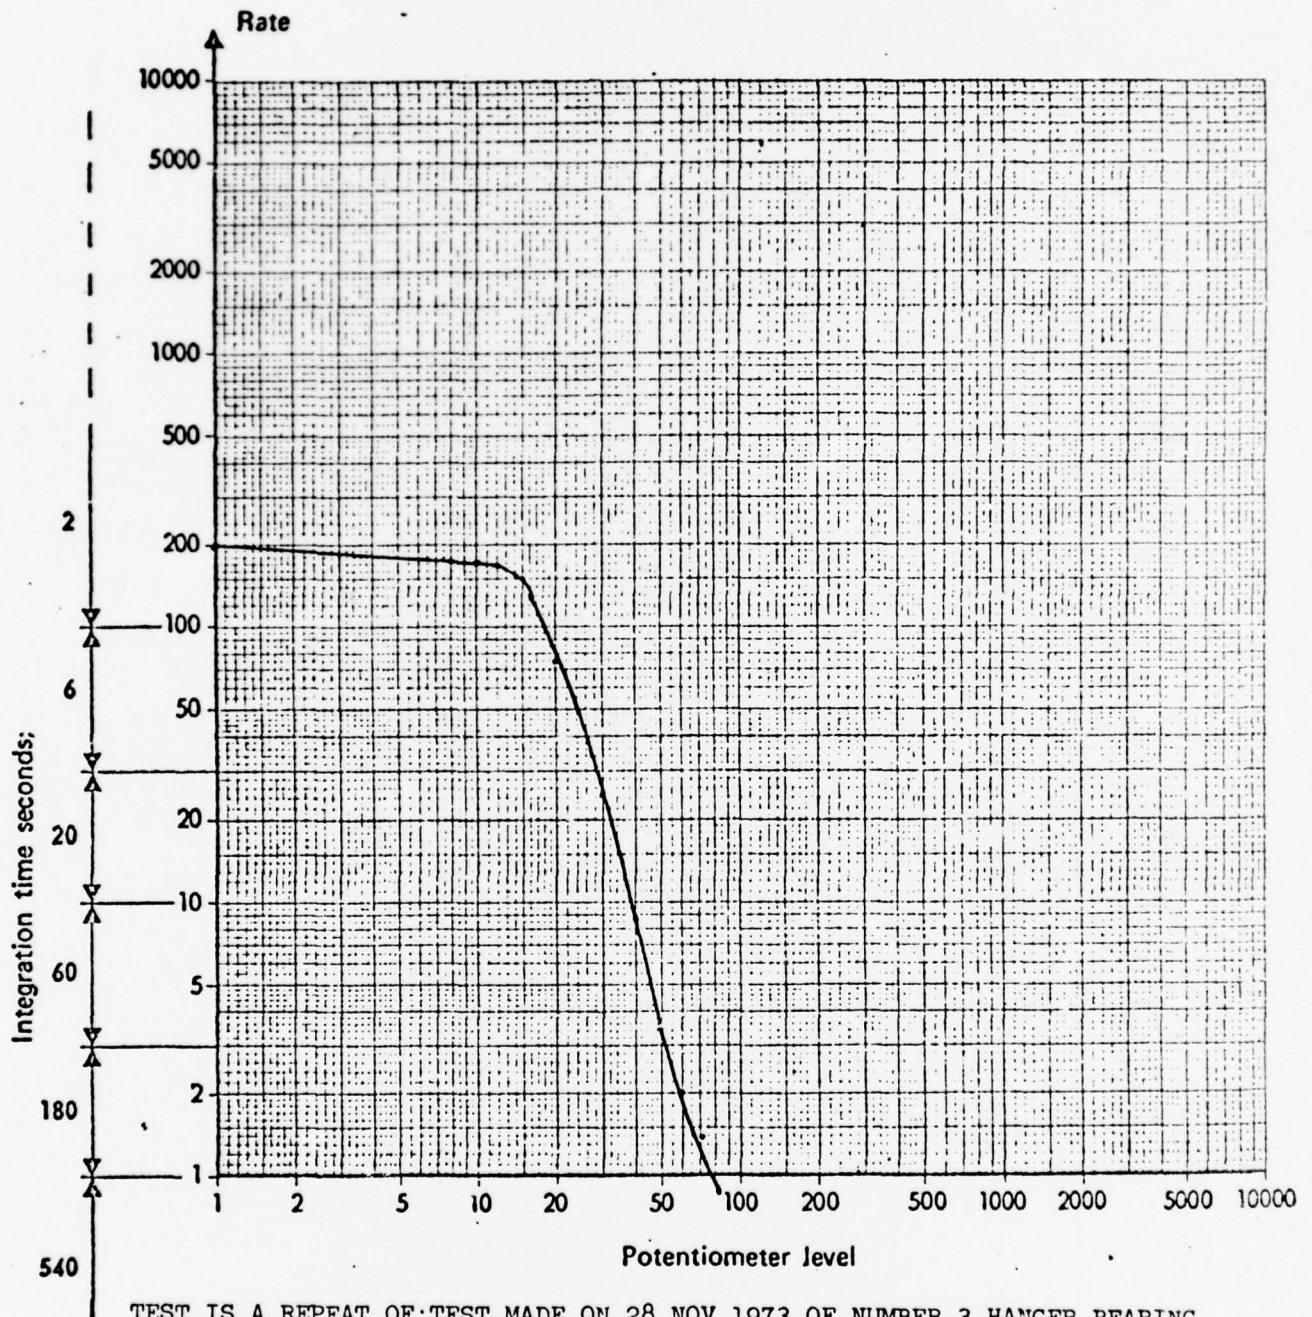
FIG. 20

TEST IS A REPEAT OF TEST MADE ON 28 NOV 1973 OF NUMBER 3 HANGER BEARING OF THE SAME AIRCRAFT WHICH WAS REMOVED FOR TEAR DOWN ANALYSIS.

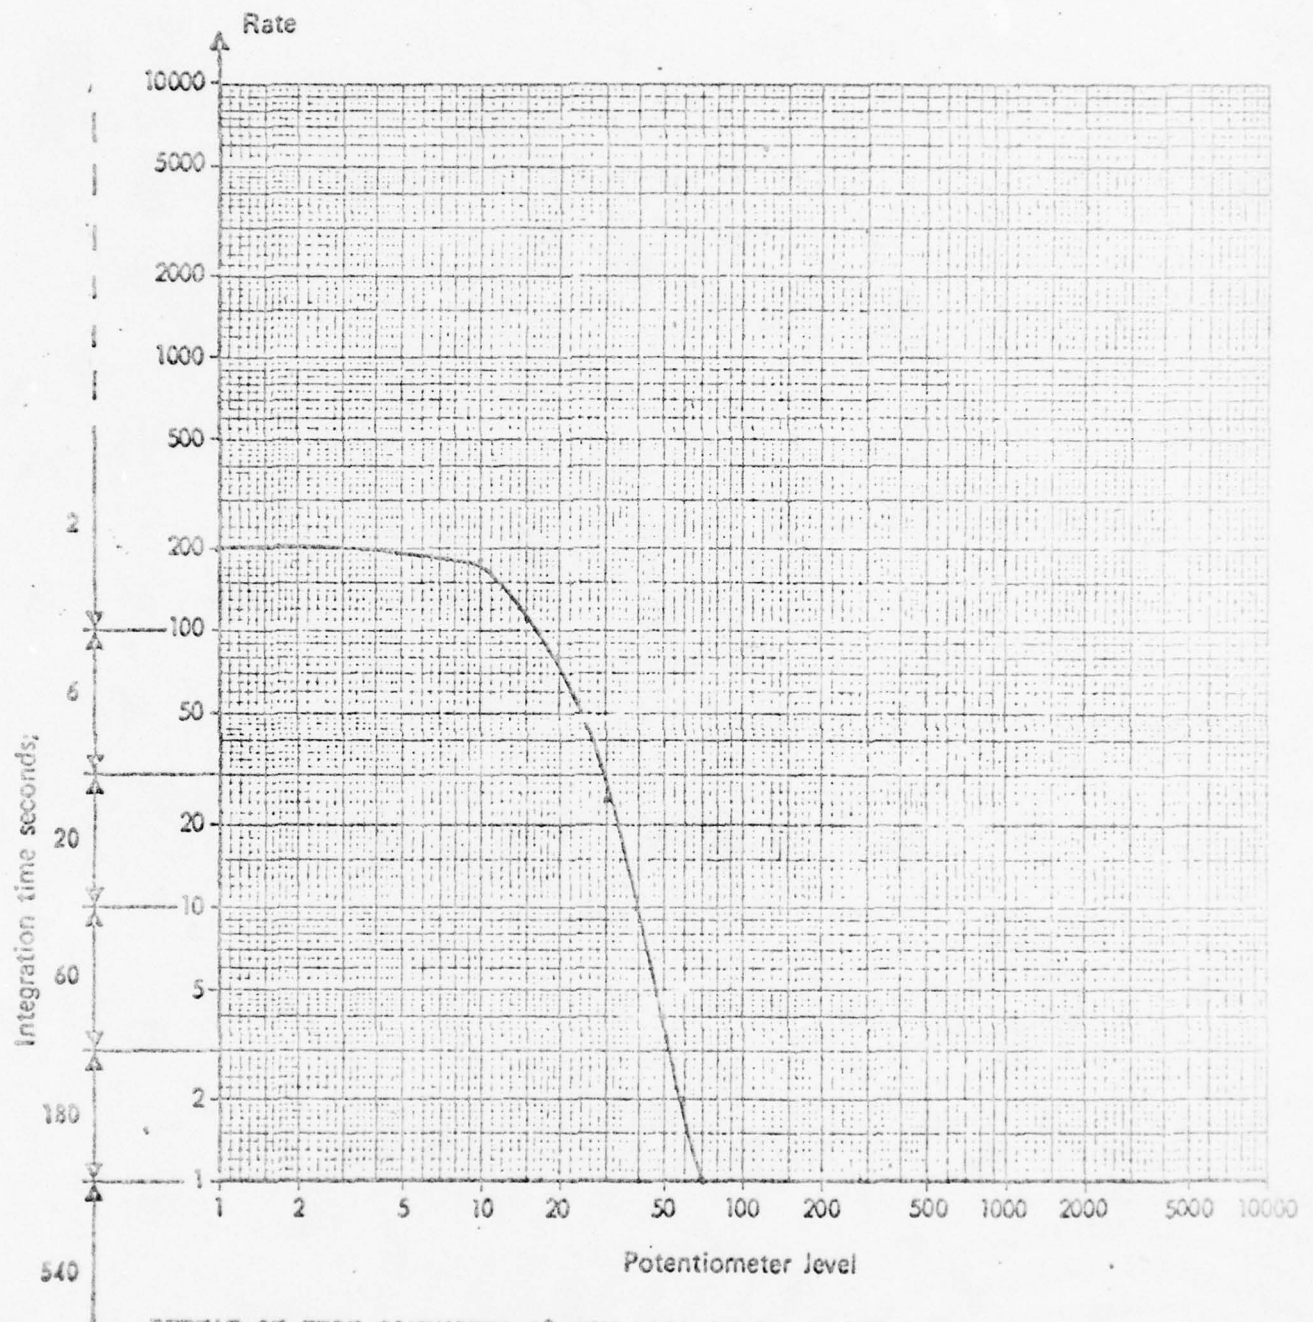
FIG. 21

REPEAT OF TEST CONDUCTED 28 NOV 1973 ON #3 HANGER BEARING WHICH WAS REMOVED FOR PHYSICAL ANALYSIS.

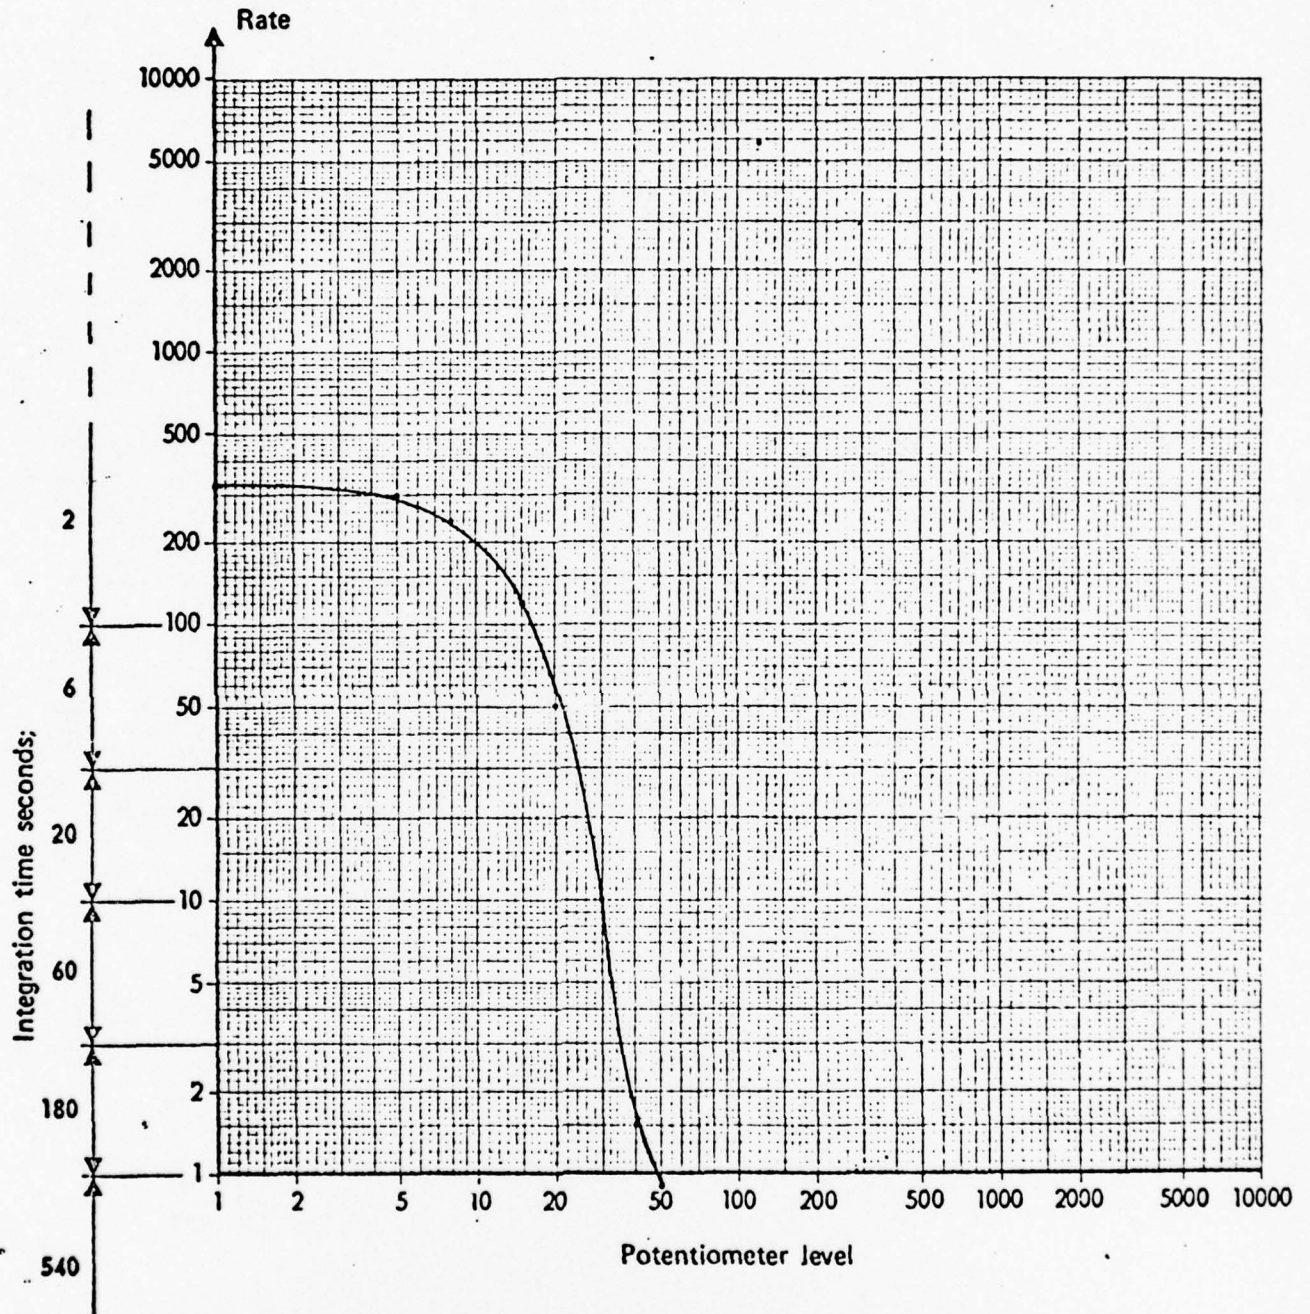
FIG. 22

REPEAT OF TEST CONDUCTED 28 NOV 1973 ON #4 HANGER BEARING WHICH WAS REMOVED FOR PHYSICAL ANALYSIS.

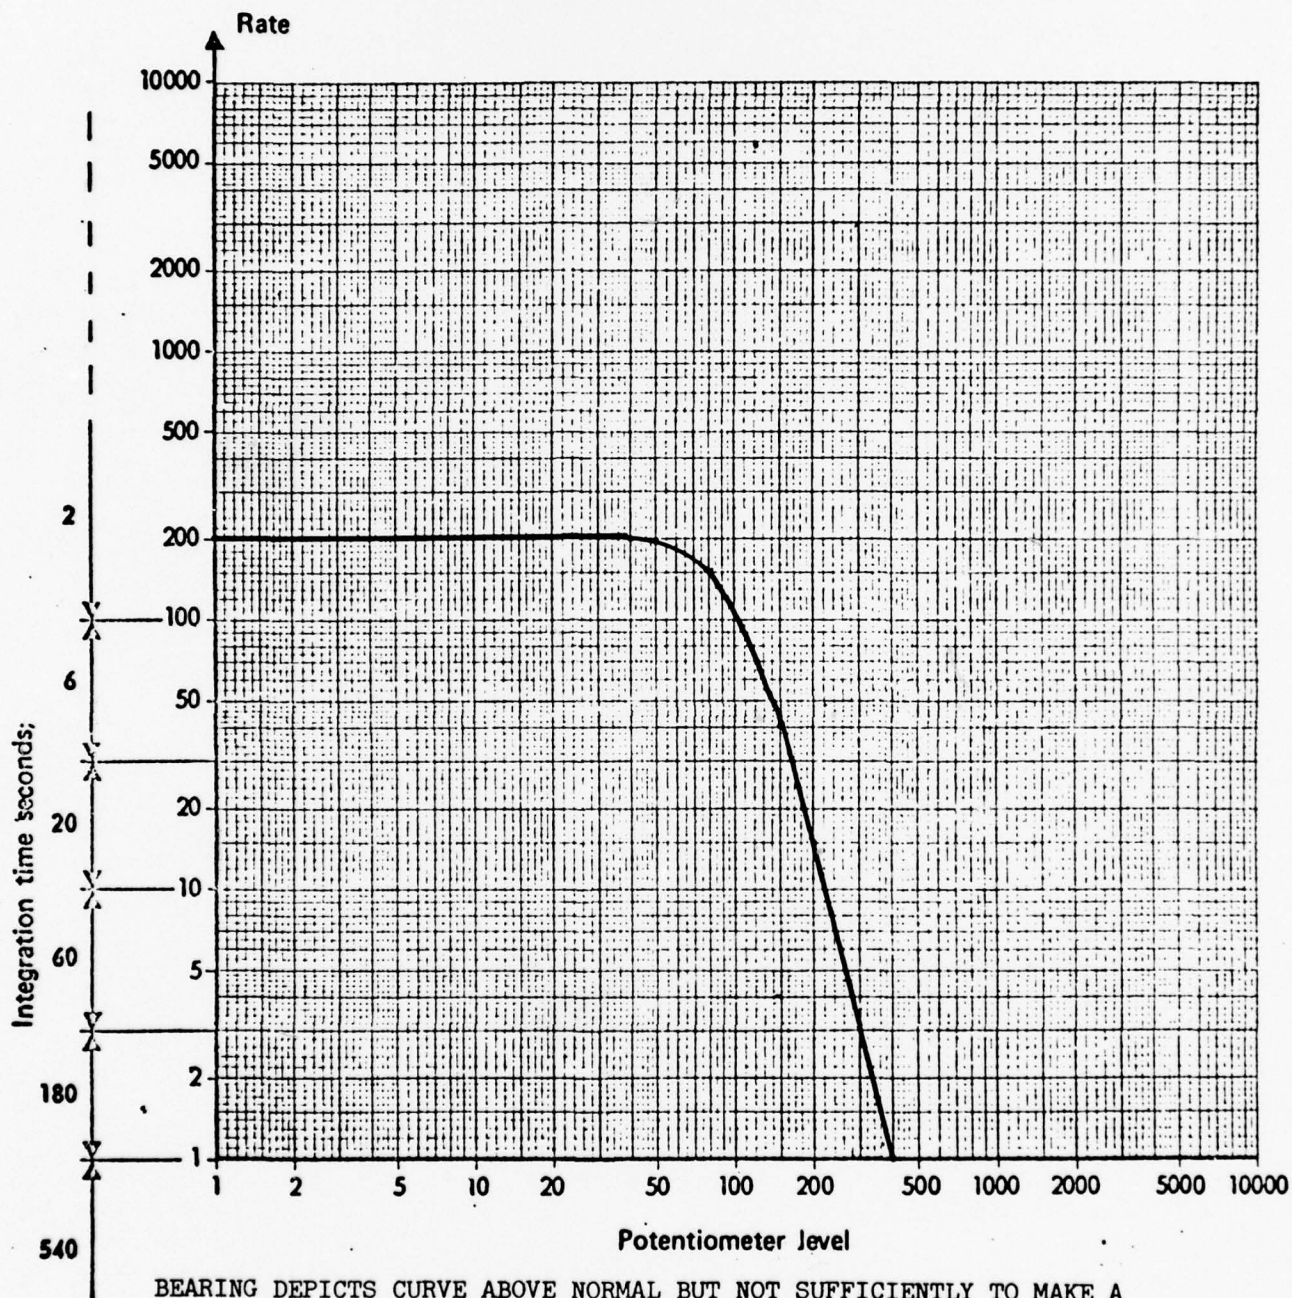
FIG. 26

BEARING DEPICTS CURVE ABOVE NORMAL BUT NOT SUFFICIENTLY TO MAKE A DETERMINATION THAT THIS BEARING IS EXCESSIVELY DAMAGED.

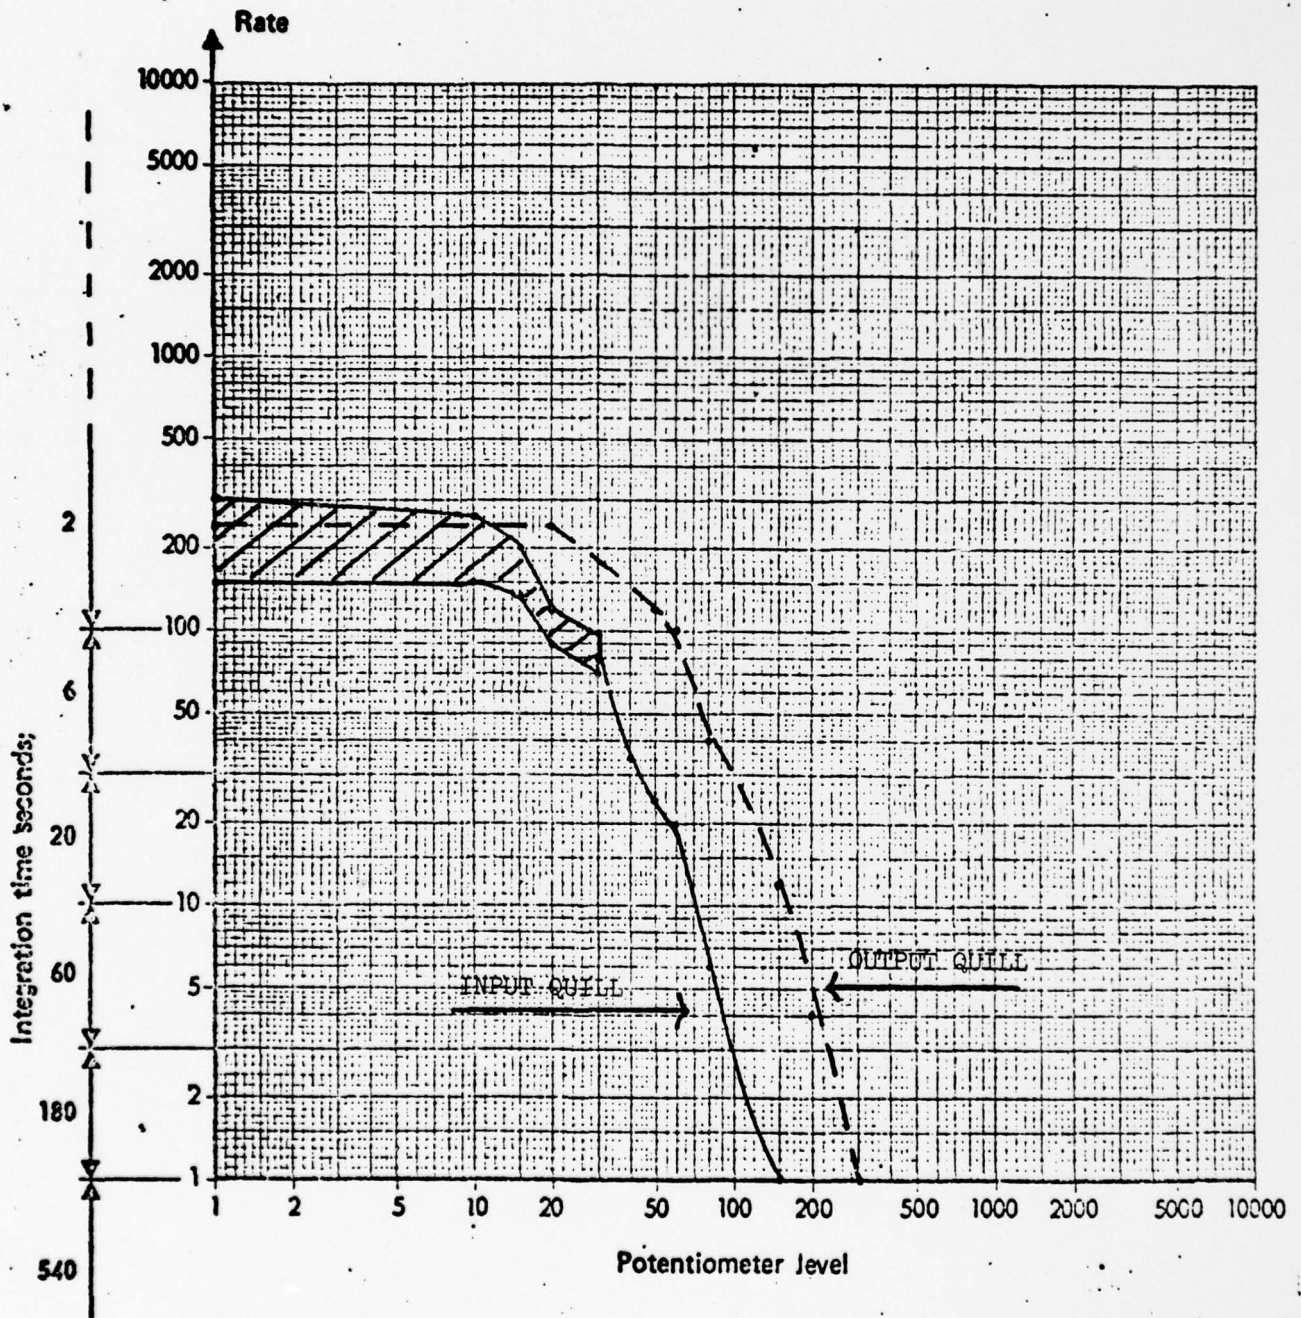
ONE CURVE REPRESENTS INPUT QUILL, THE OTHER THE OUTPUT QUILL. GEARBOX REMOVED FOR TEARDOWN ANALYSIS.

NOTE: SCALPED AREA DENOTES NEEDLE SWING.
